Re: City of Saco
Simpson Road Stone Arch Culvert
CLD Reference No. 09-0248.0040

As requested, CLD has prepared this summary of completed work and structure condition report for the Stone Arch Culvert on Simpson Road over Stackpole Creek. Included here is an abbreviated project history, structure condition update and a summary of alternatives for the City Council's consideration.

**SIMPSON ROAD
STONE ARCH INPECTION
SIMPSON ROAD
SACO, ME
FOUNDATION INPECTION
SCOUR & VOID LAYOUT**

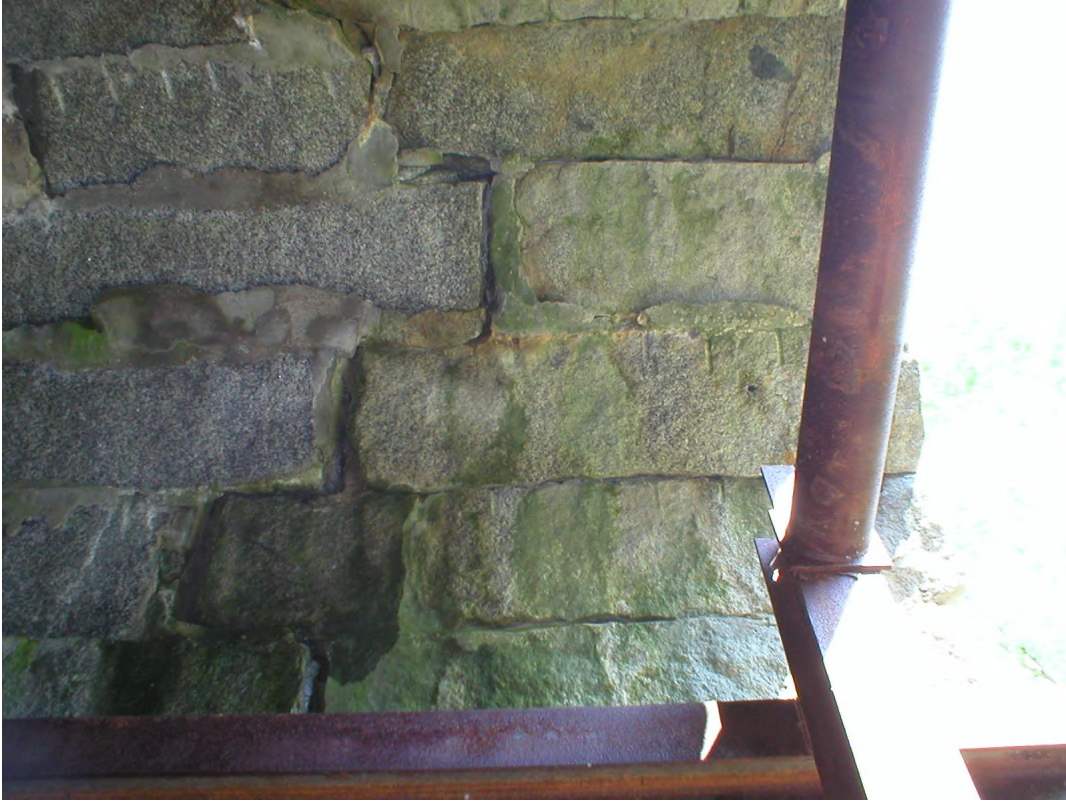
1st Radial Crack – June 11, 2003

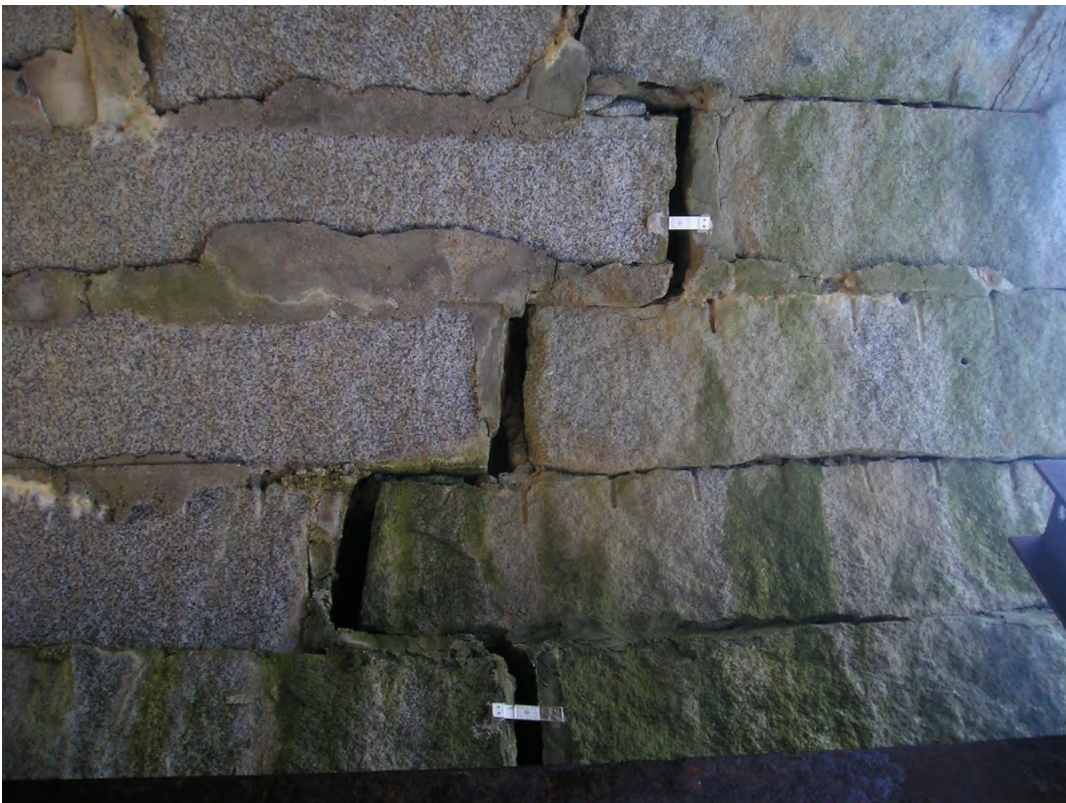
1st Radial Crack – January 11, 2011

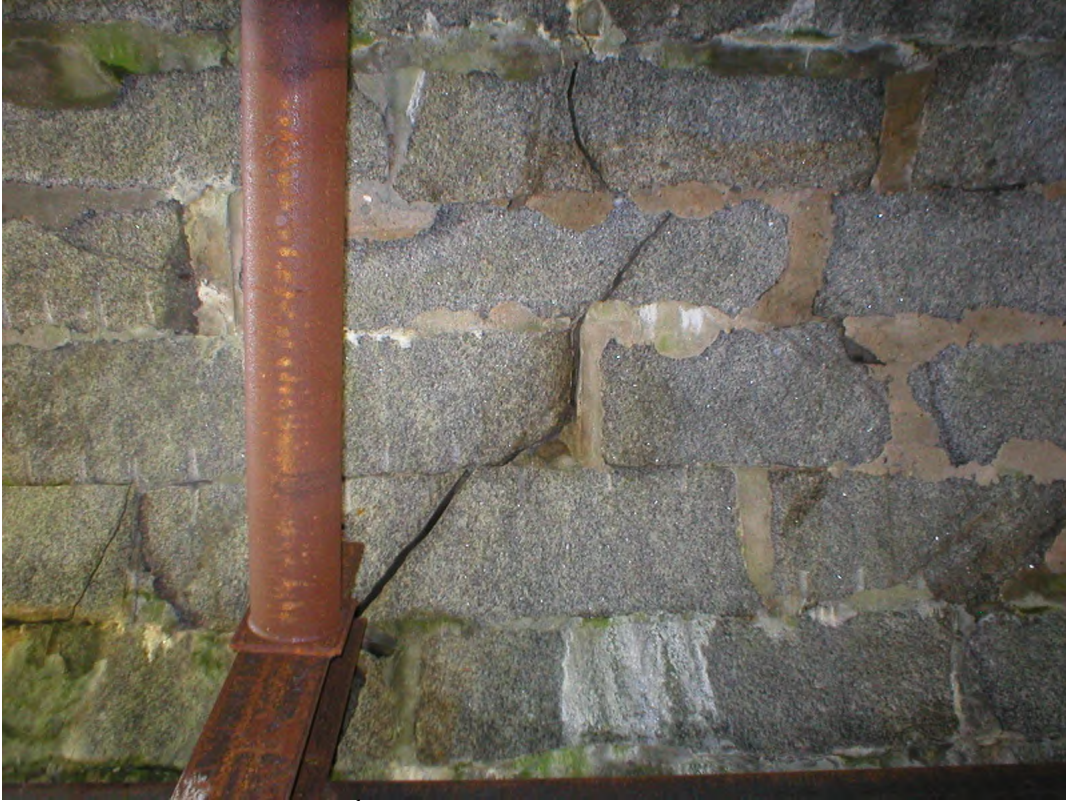
2nd Radial Crack – June 11, 2003

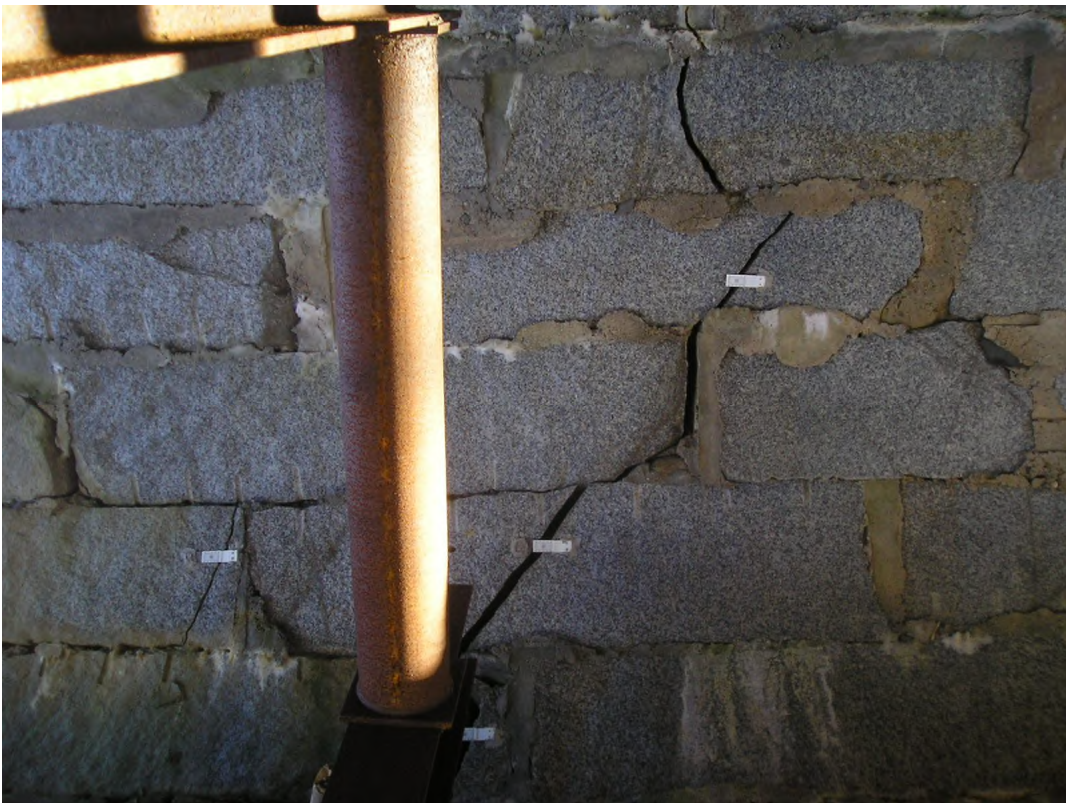
2nd Radial Crack – January 11, 2011

The gap for this radial crack increases in width after each winter season by approximately 2.5 mm and remains fairly constant during the spring, summer, and fall months. This can be attributed to the freeze/thaw cycles occurring within the bridge backfill, acting upon the arch and abutment stones.

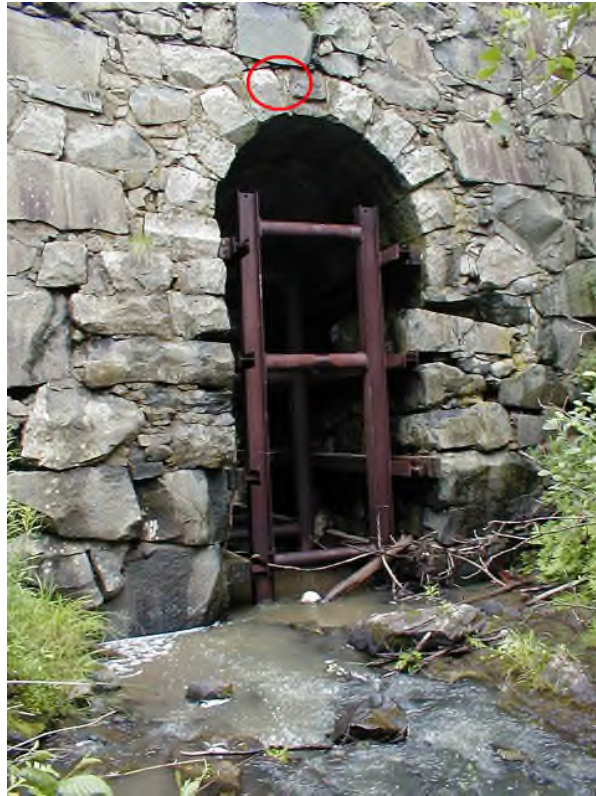
Upstream Face – July 28, 2004

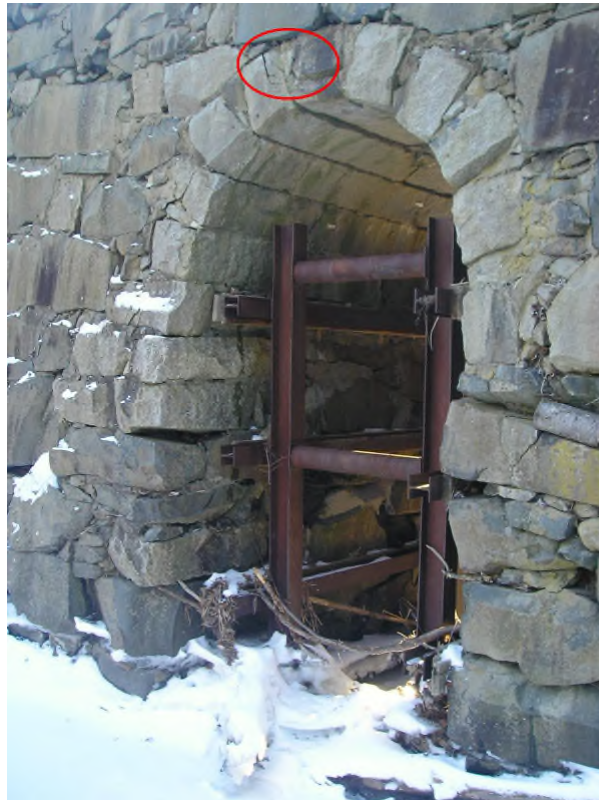
Upstream Face – January 11, 2011

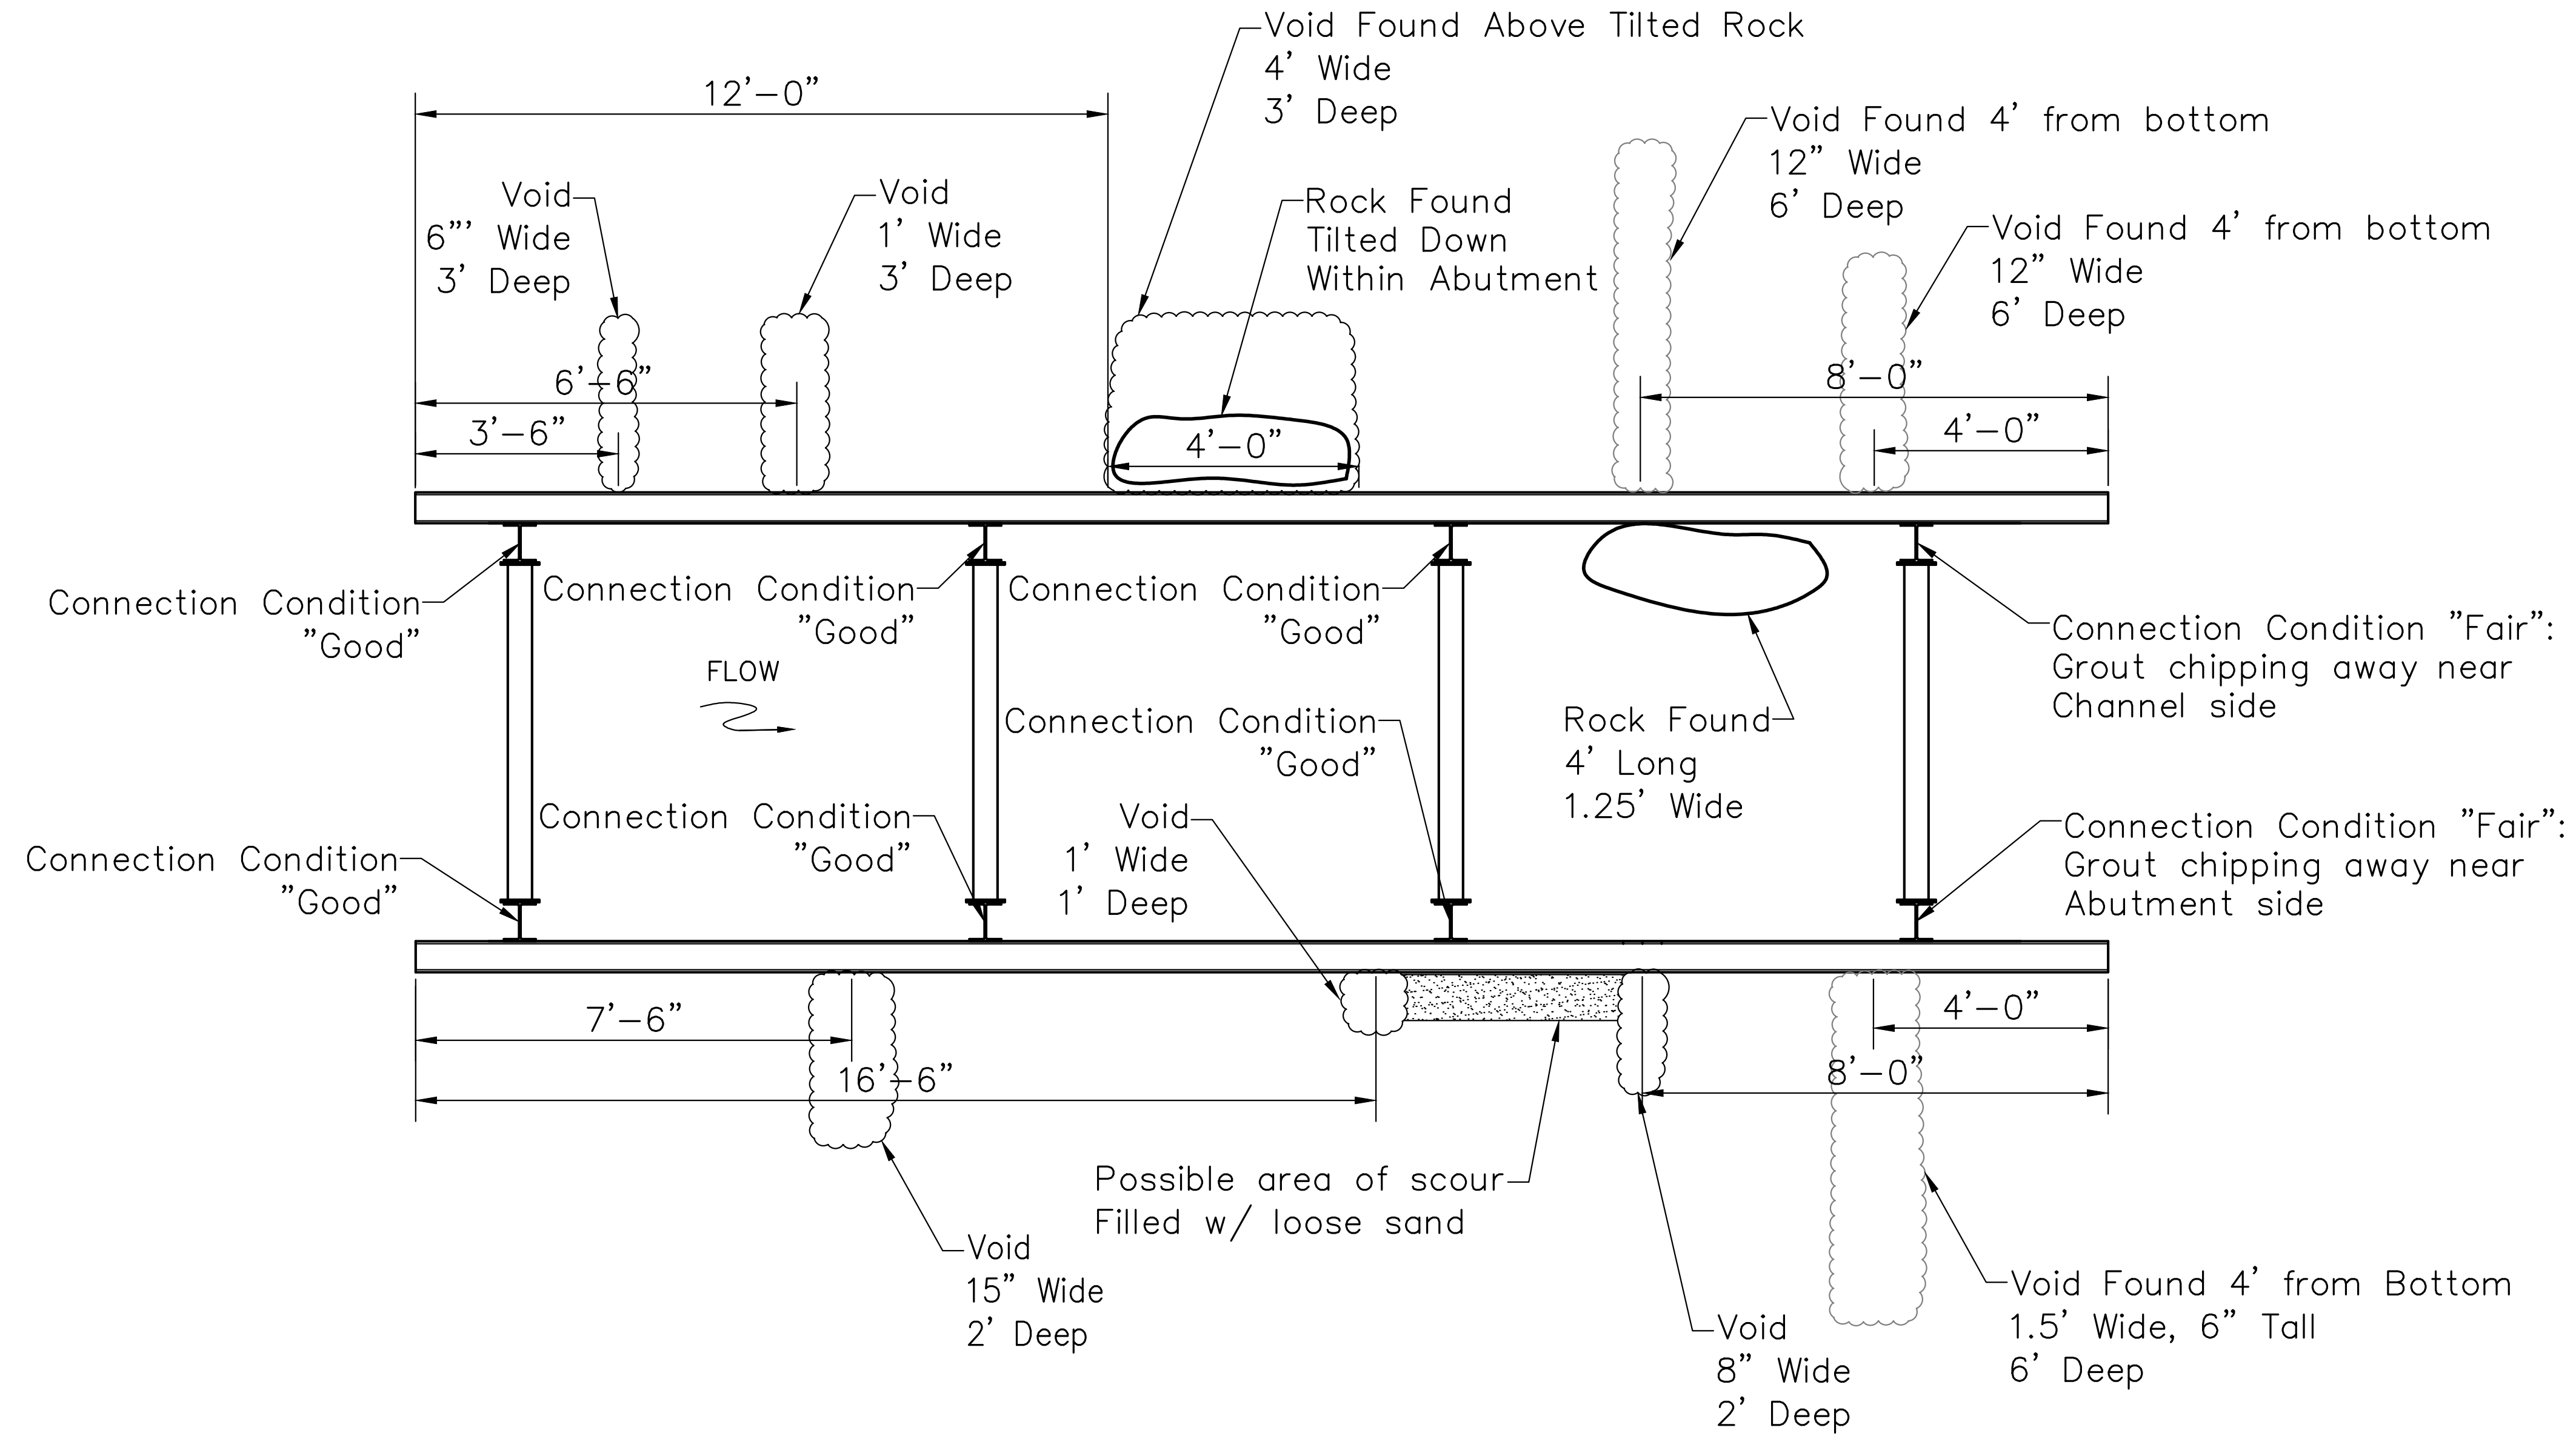
MAY 8, 2013
BRIDGE INSPECTION

* Voids Located Below Lowest Bracing (Bottom 2 feet) Unless Otherwise Noted
